Near Miss Report

Improper Application of Fall Hazard Control

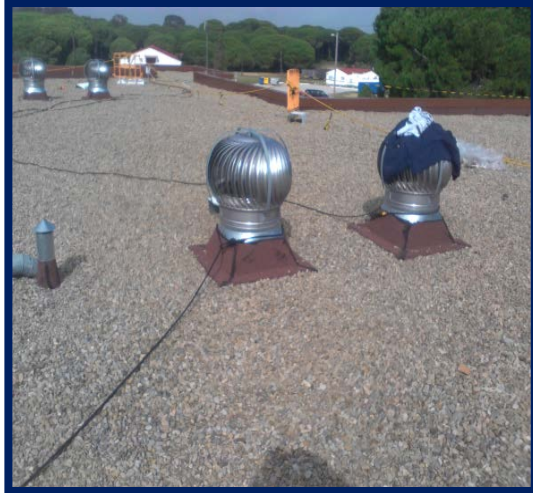
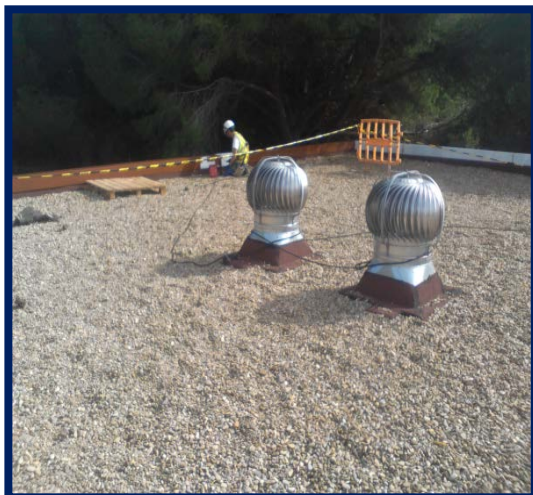
Contractor employees installing and painting a metal fascia near a roof parapet, whose height was not adequate for fall protection, used personal fall protection equipment to perform the work. They selected ventilation fans as anchorage points, which were not approved by the projects fall protection competent person. The job inspector noticed the situation as non-compliant and notified the site superintendent, who worked with the competent person to verified suitable anchorage points and discussed the necessity of involving a competent person in planning work aloft.

- Failure to properly plan the mitigation of identified fall hazards

- A fall protection competent person or fall protection compliance checklist shall be used in the planning of all projects with identified fall hazards to ensure the fall hazard controls are planned and implemented correctly
- Employees shall be adequately trained and authorized to use the required personal fall protection equipment, and the fall protection competent person shall verify equipment is used according with standard practice
